MANUFACTURING METHODS TECHNOLOGY (MM&T) FOR BALLISTICALLY TOLERANT REPLACEMENT FLIGHT CONTROL COMPONENTS

Rune Anderson
Whittaker Corporation
Research and Development Division
San Diego, Calif. 92123

July 1974

Final Report for Period May 1972 - February 1974

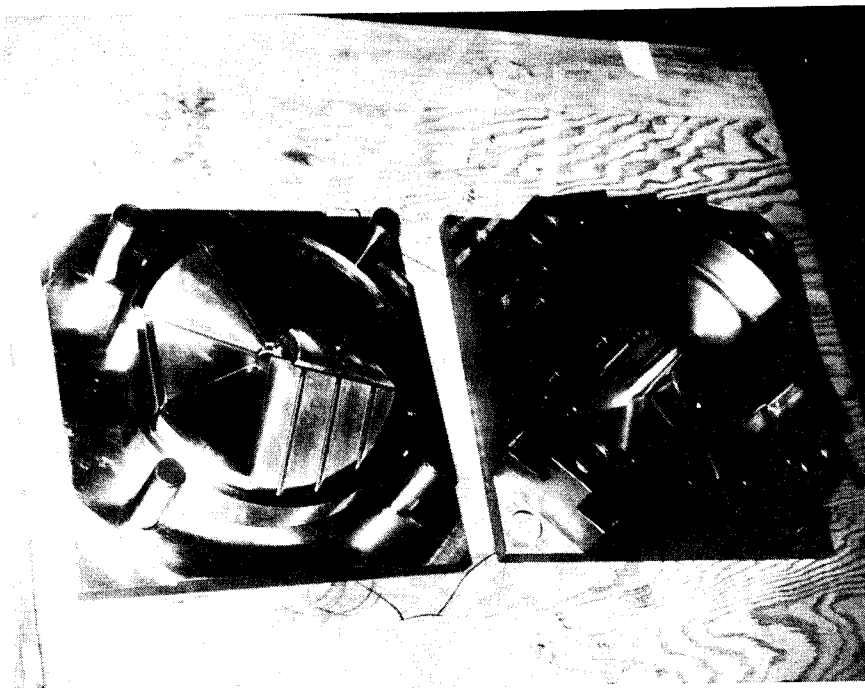
Figure 3. Compression Mold for Quadrant Upper Disc.

cooler than the guide pins which extended down to the primary heating surface. Thus, interference was caused between the guide pin and bushing during opening. The problem was finally resolved by increasing the clearance between the bushing and the guide pin to permit such heat gradients and still make the tool operational. Once this had been accomplished, details were readily molded. The complex configuration of the mold for the quadrant upper disc is shown in Figures 3 and 4.

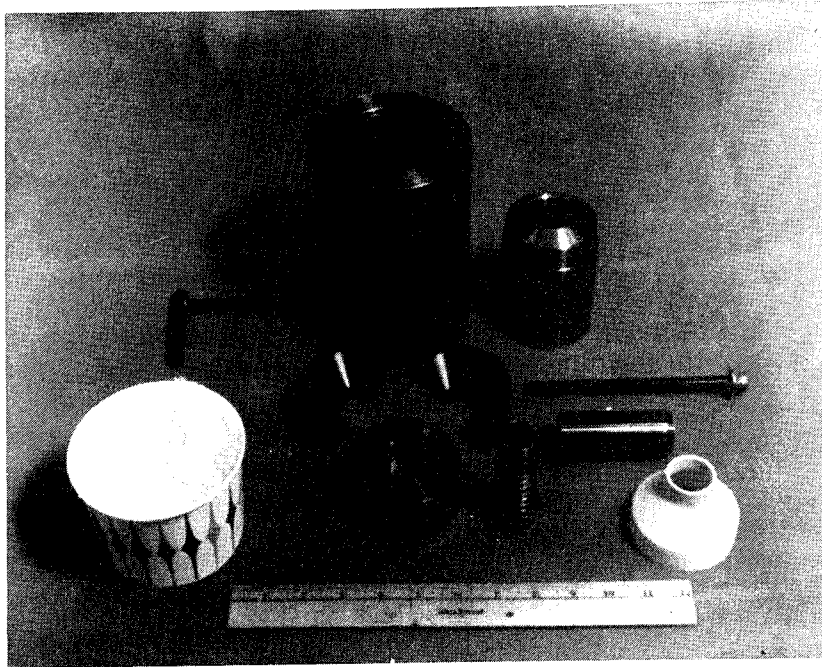
Figure 9. Mold for End Fitting.

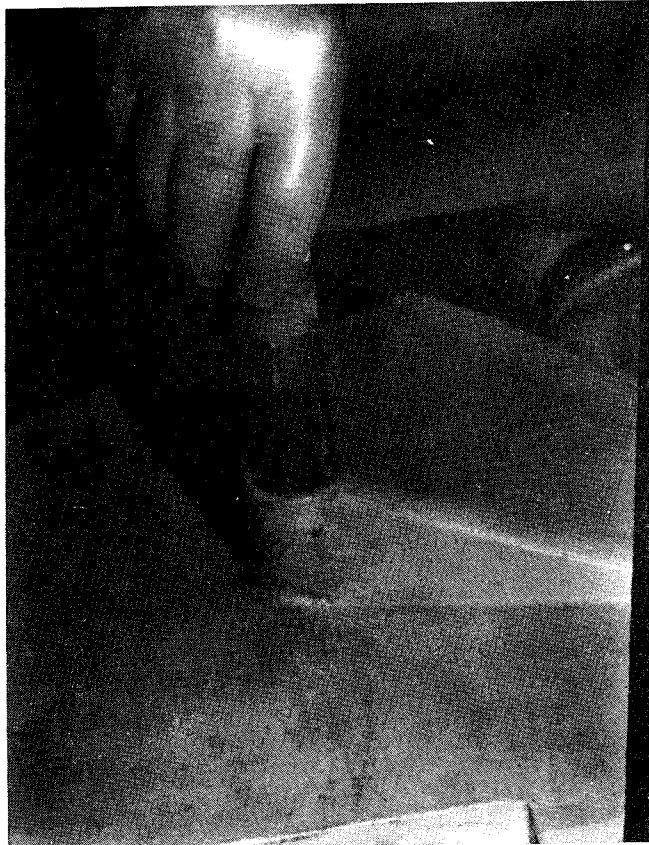
Figure 21. Installing Center Tube in Molded
Quadrant Disc.
